# A Case Study

## The Consequences of selecting the wrong Motor Base

Called by a mine to investigate the failure of a 45kW motor base on a vibrating screen drive, we found a relatively new unit of a type developed more than 25 years ago and entirely unsuitable for the application.

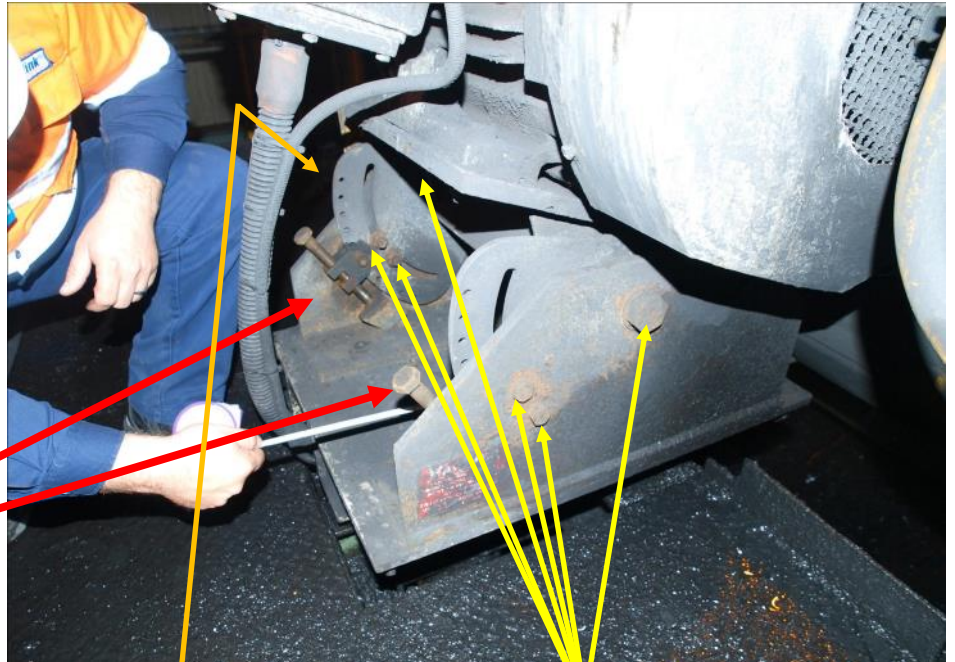
*High corrosion was evident.*

**2 adjusting screws  
Open threaded & Corrosion**

**Pinch Points**

**6 locking bolts  
& Corrosion**

**We replaced the failed motor base with a Leverlink LPST-5 Motor Base with a 5 year Warranty**

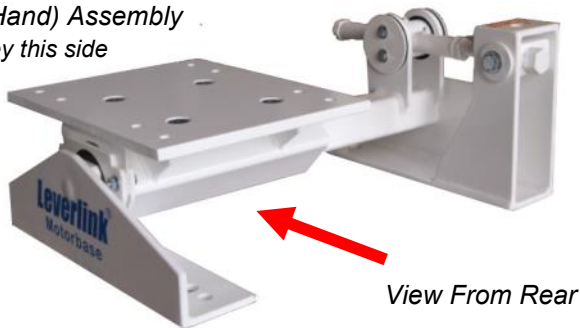
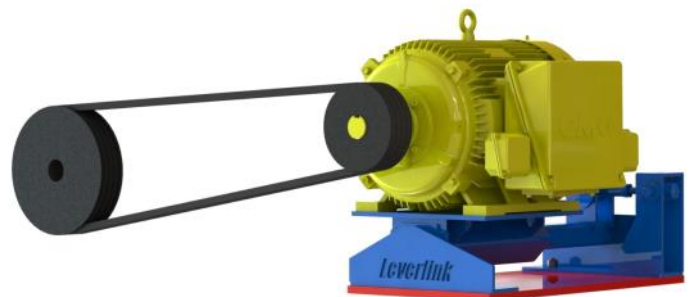
*LH (Left Hand) Assembly  
Drive Pulley this side*

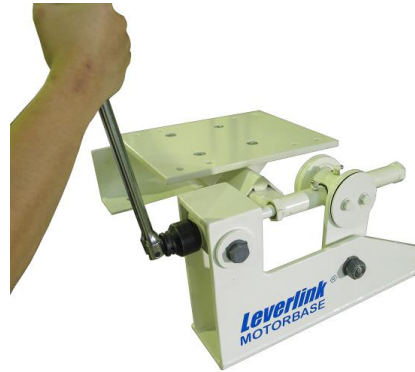
VEE Belt Adjustment

- Clear of all Pinch Points.

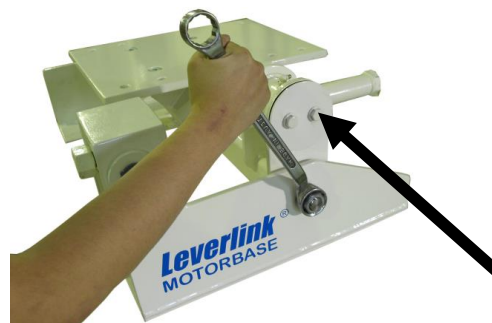
Tensioning Mechanism fully enclosed and lubricated. No seizers can occur.

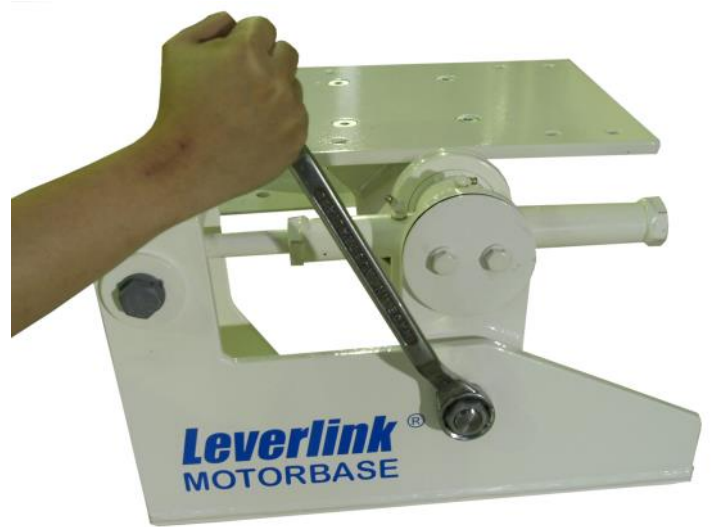
**1.** Crack the locking nut.

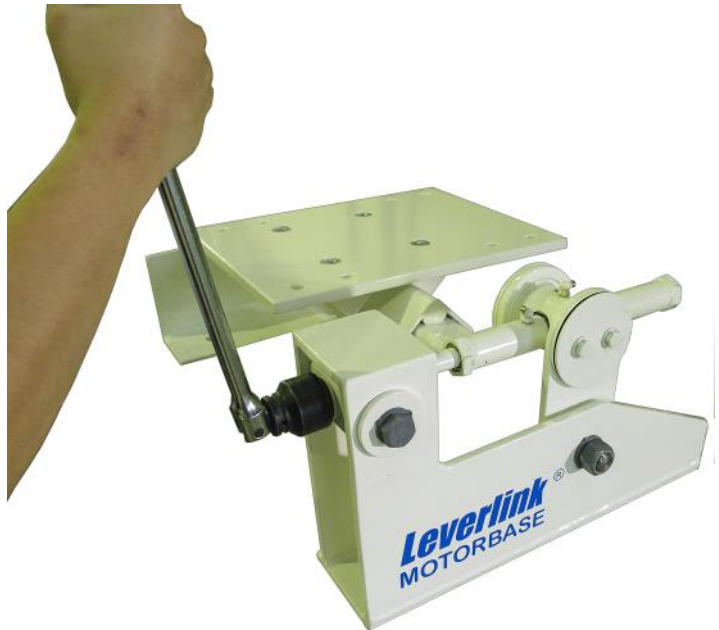
**2.** Change or adjust the VEE belts.

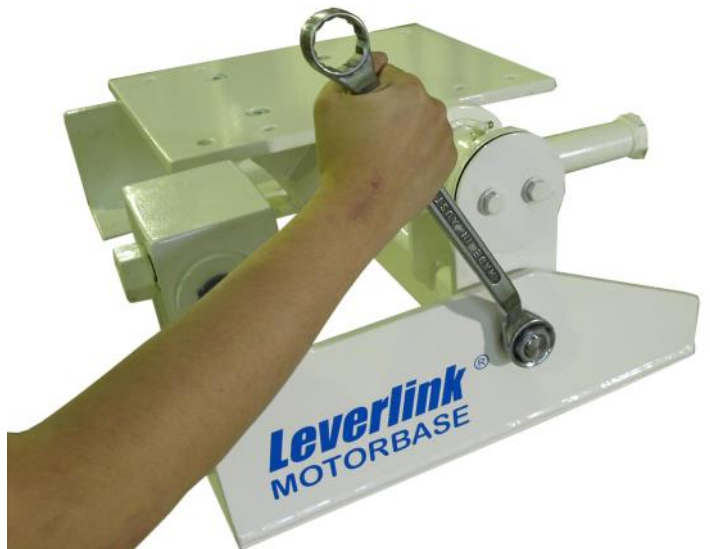
**3.** Tighten the locking nut.
